Intel[®] Celeron[®] Processor Specification Update

Release Date: January 02

Order Number: 243748-041

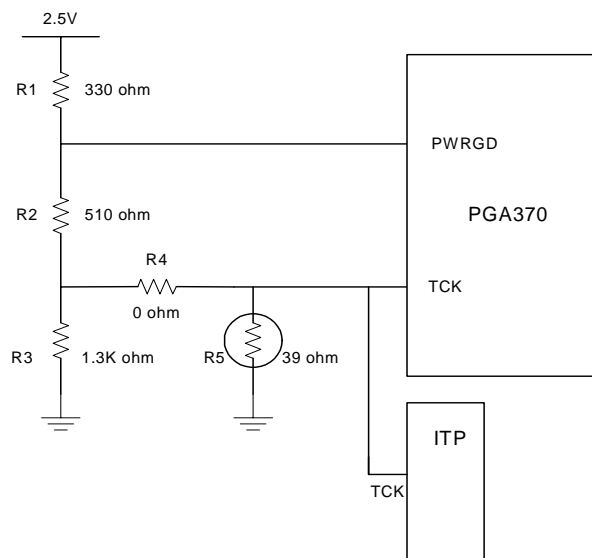
Celeron® on 0.13 micron Processor 256K Platforms Workaround

In addition, the example workaround circuits shown do not support production motherboard test methodologies that require the use of the processor JTAG/TAP port. Alternative workaround solutions must be found if such test capability is required.

For Production Boards:
Depopulate R5

To use ITP:
Install R5, Depopulate R4
